Manhole Inspection Summary

Manhole # S23GG1028MH

Inspection ☐ Is Incomplete Rating: **4) Poor**

Location Address: **1441 MEDFIELD AVE**

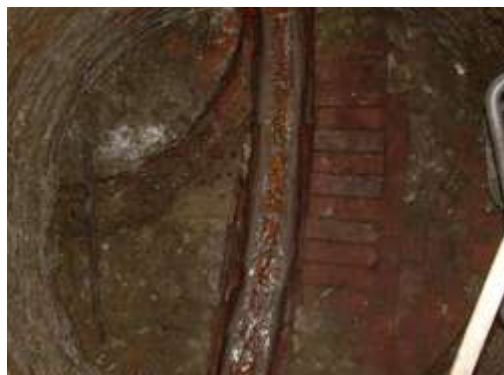
Top View

Evidence of surcharge - Bench debris.

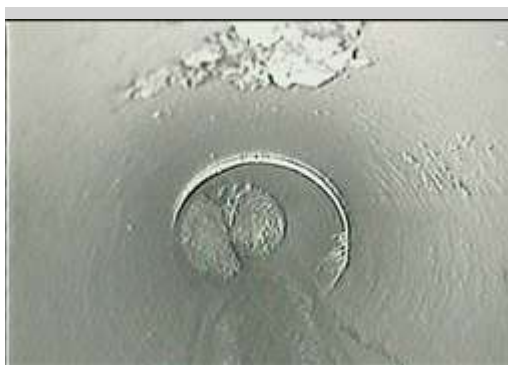
Inside the O12

Corbel deterioration, root intrusion and infiltration.

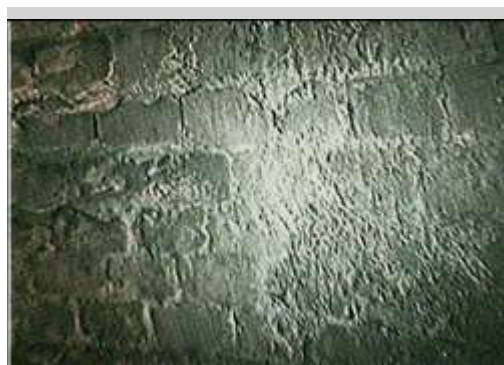
Defect

Frame leaks. Frame offset. Adjustment infiltration.

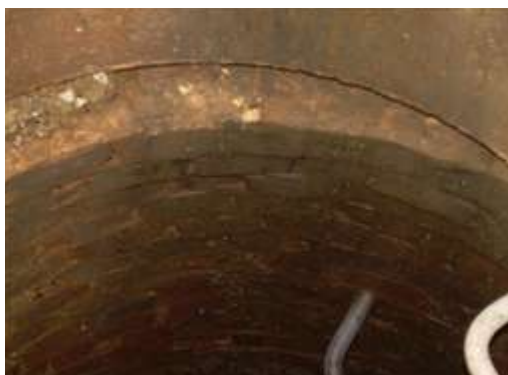
Defect

Frame leaks. Adjustment deterioration, loose brick and infiltration.

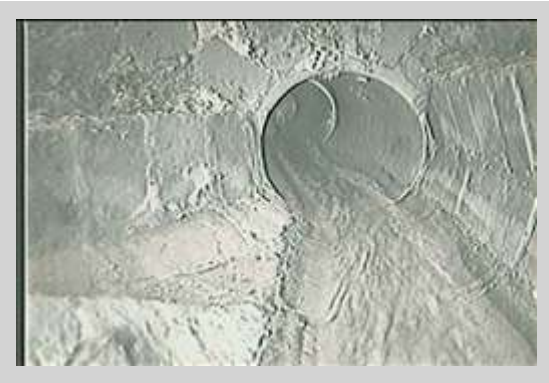
8 in. Circular Gravity Sewer Pipe Out @ 12 O'Clock

Barrel deterioration and infiltration.

Infiltration: **Evidence** Pipe Seal Cond: **Roots**

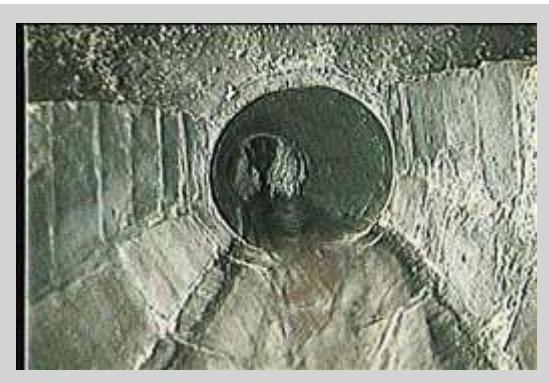
8 in. Circular Gravity Sewer Pipe In @ 6 O'Clock

Channel deterioration.

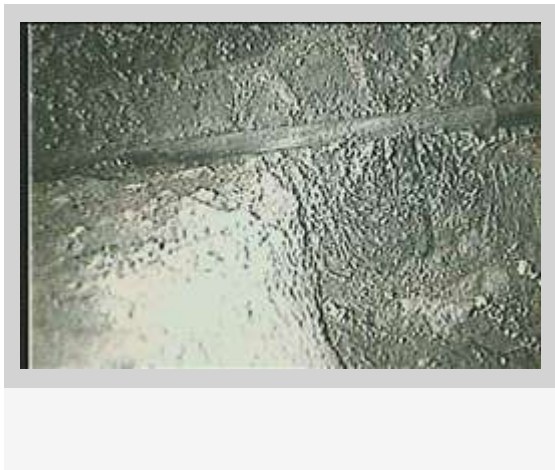
6 in. Circular Gravity Sewer
Pipe In @ 9 O'Clock

Deposits: ☐ None ☒ **Mud** ☐ Sludge ☒ **Debris** ☐ Grease

Silt Depth: **2** (in.) Deposits Extent: **Medium**
